**THE STREAMBANK EROSION CONTROL
EVALUATION AND DEMONSTRATION ACT OF 1974
SECTION 32, PUBLIC LAW 93-251**

Appendix F - Yazoo River Basin Demonstration Projects

Consisting of
A COMPREHENSIVE SUMMARY REPORT ON STREAMBANK
EROSION CONTROL DEMONSTRATION PROJECTS CONSTRUCTED
IN EIGHT WATERSHEDS OF THE YAZOO RIVER BASIN

U.S. ARMY CORPS OF ENGINEERS
December 1981

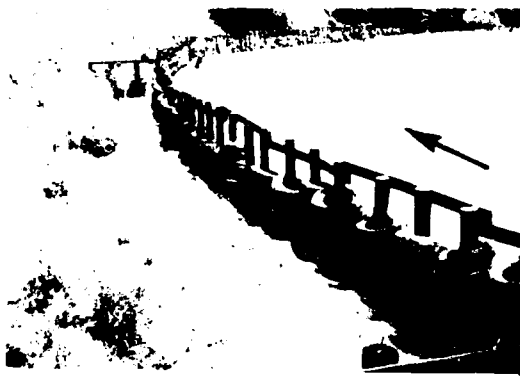
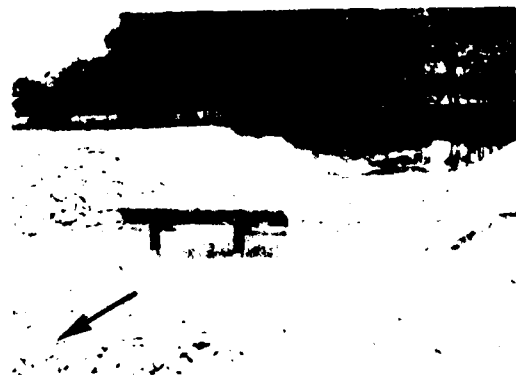
Figure 16. Typical photographs of structures on Perry Creek

Tire Post Retards

Peaked Stone Dike

Longitudinal Stone Dike

Wire Crib Retards
Tire Filled with
Stone Toe

Grade Control Structure
with Hanging Baffle

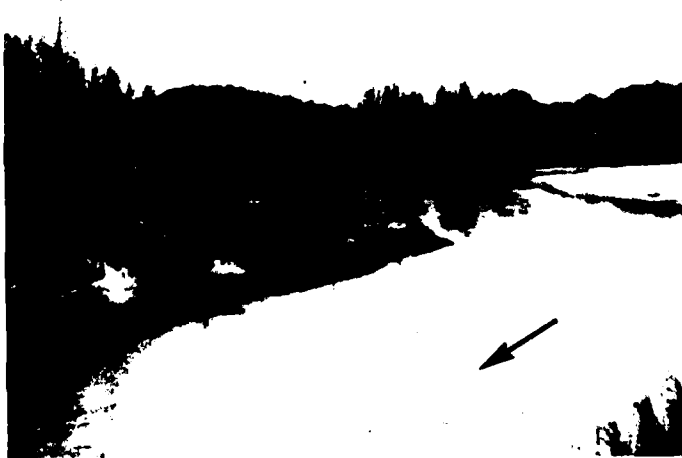
Figure 47. Batupan Bogue, Item 4, Reach 7

After Rehab
Mar 1980

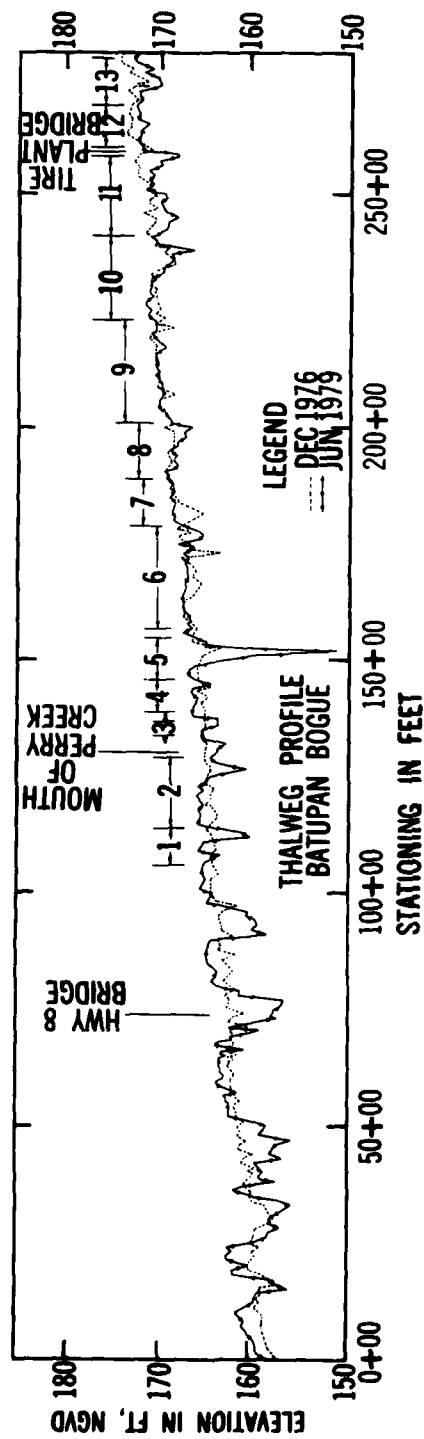
Figure 54. Batupan Bogue Thalweg, 1976 and 1979

With the exception of a few reaches, the Item 4A work has generally had little launching of the stone toe protection due to scour, even where massive bank failures have occurred. According to comparative thalweg profiles (Figure 54), the streambed between Reach 1 and Reach 9 has remained relatively stable with only localized areas of scour and fill. This indicates the presence of a consolidated streambed which the stream cannot penetrate; therefore, during high flows the banks are scoured rather than the bed. Because of the consolidated bed material, the bank failures are due to the erosive forces of the stream impinging on the upper banks, rather than as a result of an oversteepening of the banks following a lowering of the streambed. In areas where geologic bed controls exist, complete upper bank protection with minimal toe protection may be the most suitable design. This design differs considerably from actively degrading streams such as Perry Creek where toe protection is essential to providing adequate bank protection. It is important to recognize that a complete study of the area is necessary to insure that the optimum stabilization techniques for the stream are selected. Several factors such as alignment, incomplete upper bank protection, and

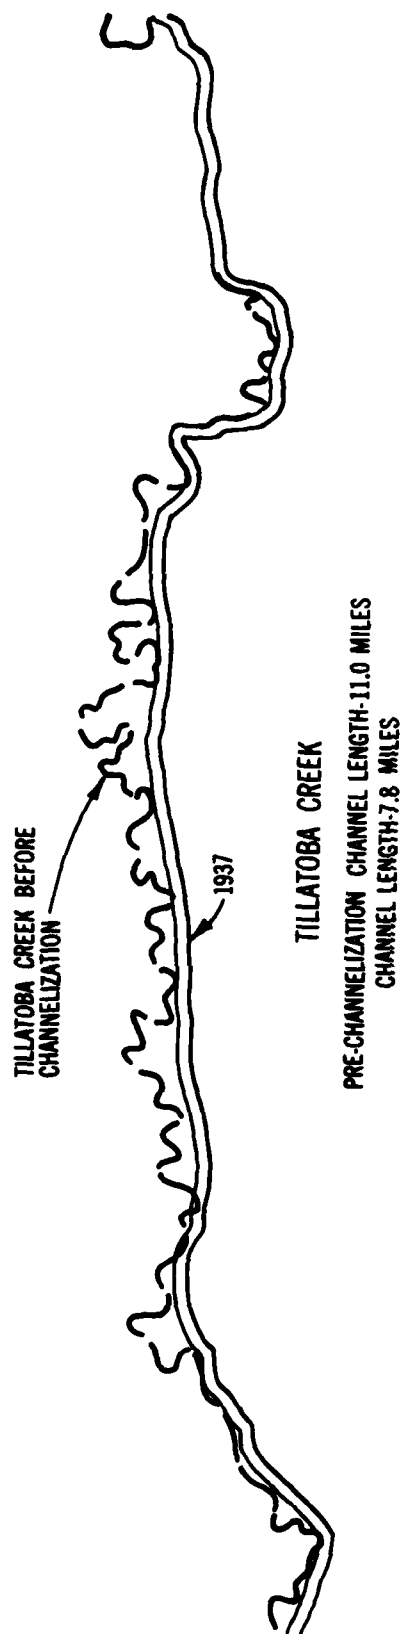
Figure 64. Plan view comparison, Tillatoba Creek after channelization

7. Channel Changes. Ninety-nine percent of the Tillatoba Creek Basin is in the Yazoo Basin hills. The 7.8 miles of channel in the delta were channelized during the 1920's and 1930's (Figure 64). Middle Fork, tributary to South Fork, is the only channel in the basin to be partially channelized.

Figure 64 shows the channelization and straightening of the Tillatoba Creek stream channel in the delta flatlands prior to 1937 and the considerable reduction in channel length (Whitten & Patrick, 1980). Photos indicate the channel width doubled from 1937 to 1979. The increase in width may have occurred at a uniform rate, unlike the well-defined erosion locations of degradation in upland channels.

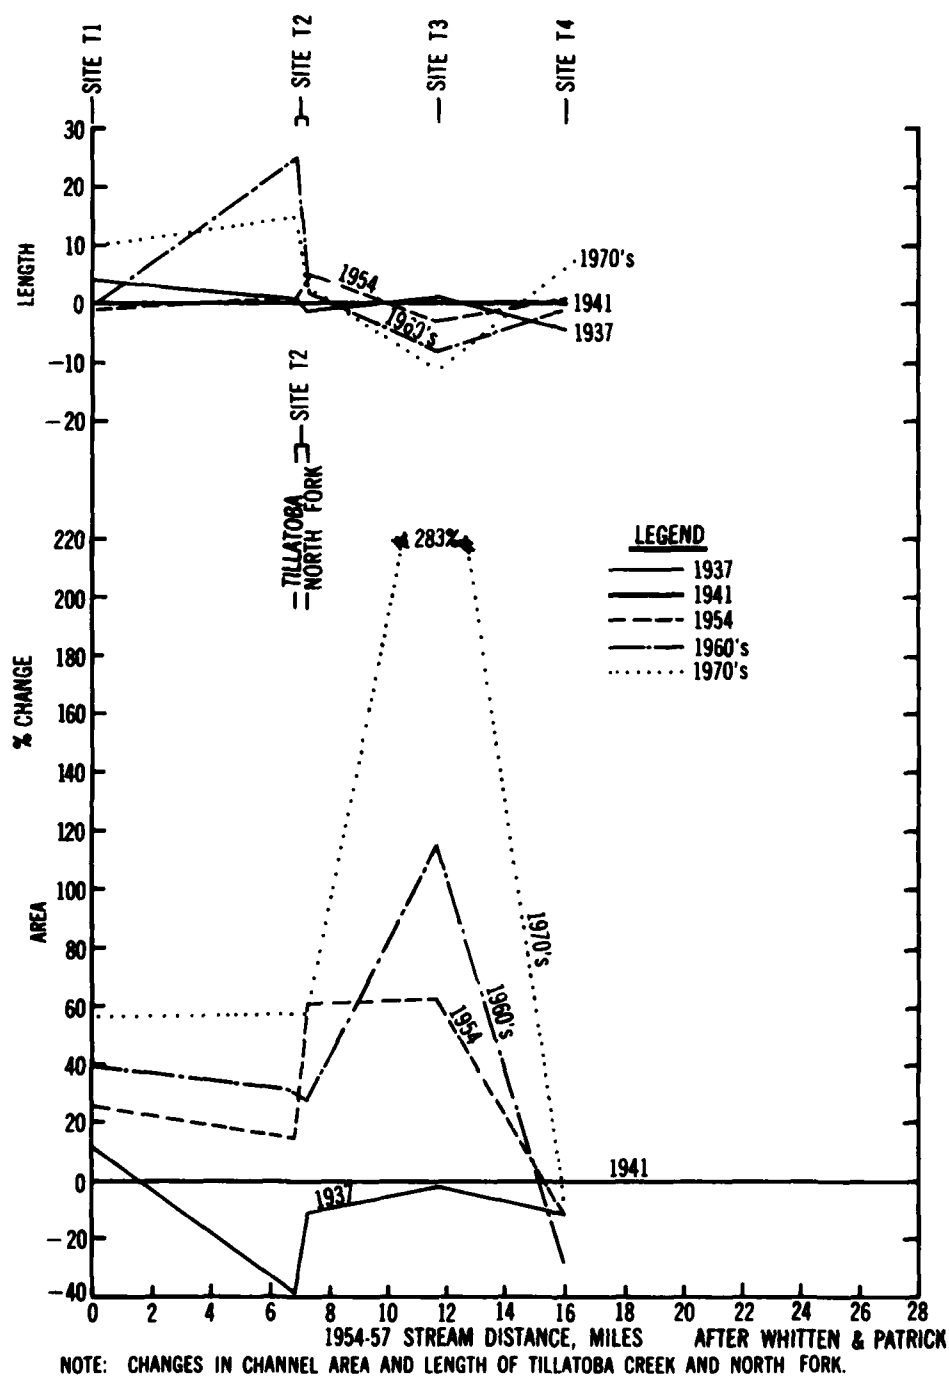
Figure 69. Changes in area and length of Tillatoba Creek

"The only significant channel erosion in the 1937 Tillatoba Creek Basin was in the small upland channels directly associated with active gullying. All of the channels in the 1941 basin appear to have been eroded to some extent. The only extensive erosion of a major channel occurred in Tillatoba Creek. The channel erosion has been advancing upstream on the major upland channels and their tributaries since 1941. The 1954 longitudinal profiles of the major channels are very irregular, especially in the lower reaches (Figure 68). Comparison of the 1954 and 1976 longitudinal profiles show the channels have degraded as the knickpoint(s) advanced

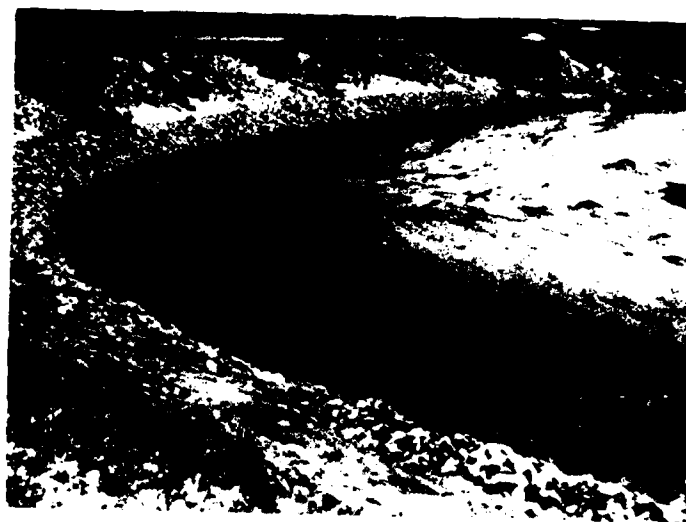
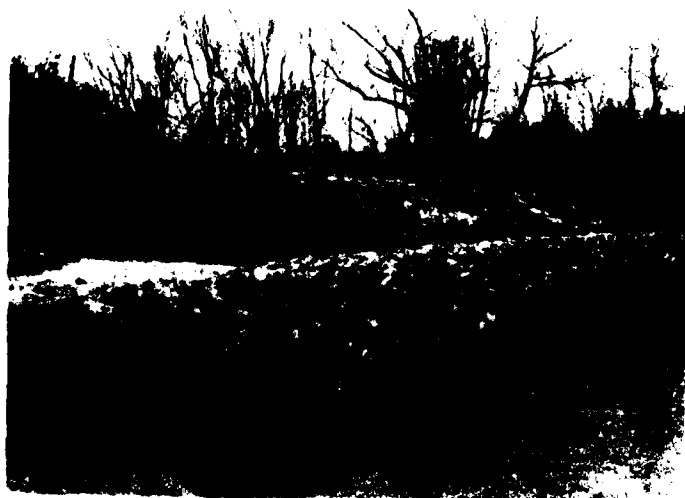
Figure 87. Photographs of longitudinal stone dikes

Longitudinal Stone Dike
with Vegetation
Sept 1976

Longitudinal Stone Dikes
with Stone Tie Backs

Longitudinal Stone
Dike with Upper Bank
Protection in Place
Feb 1979

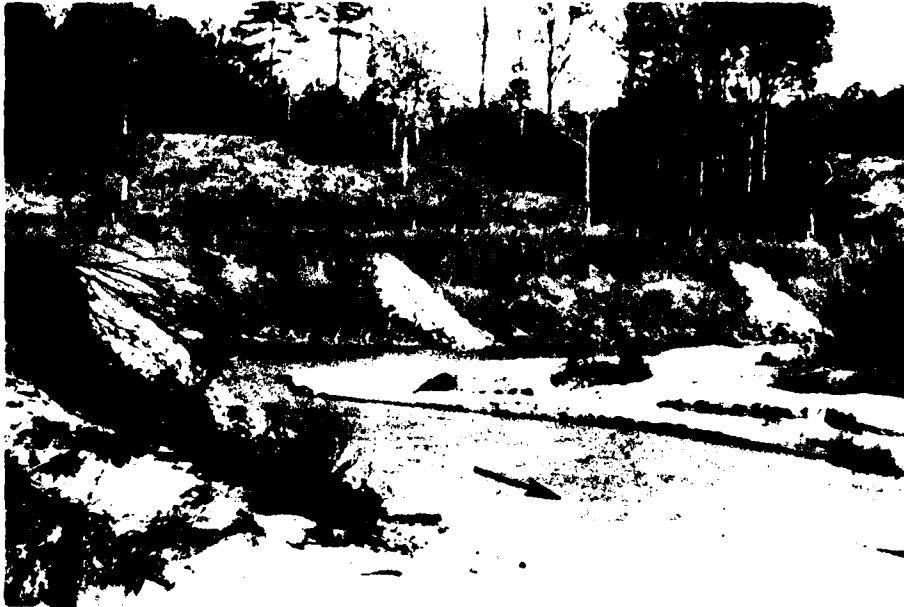
Figure 88. Photographs of transverse stone dikes

Stone Transverse Dikes in Sharp Bend

Stone Transverse Dikes with Scour
Downstream of Dike North Fork Tillatoba

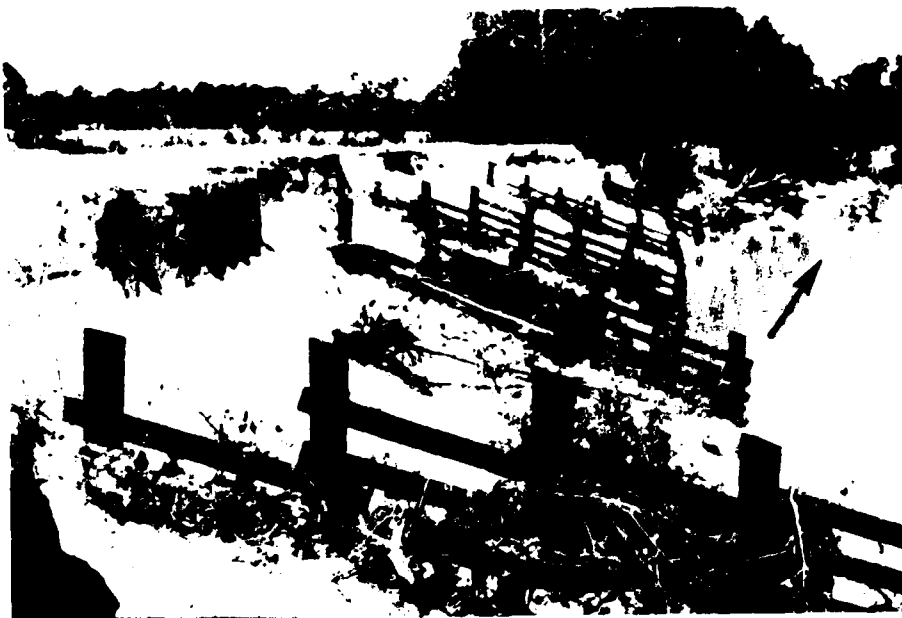
Figure 89. Photographs of transverse board fence dikes

Transverse Board Dike
South Fork Tillatoba
April 1974

Transverse Board Dike
South Fork Tillatoba FY 73 Work
Dec 1976

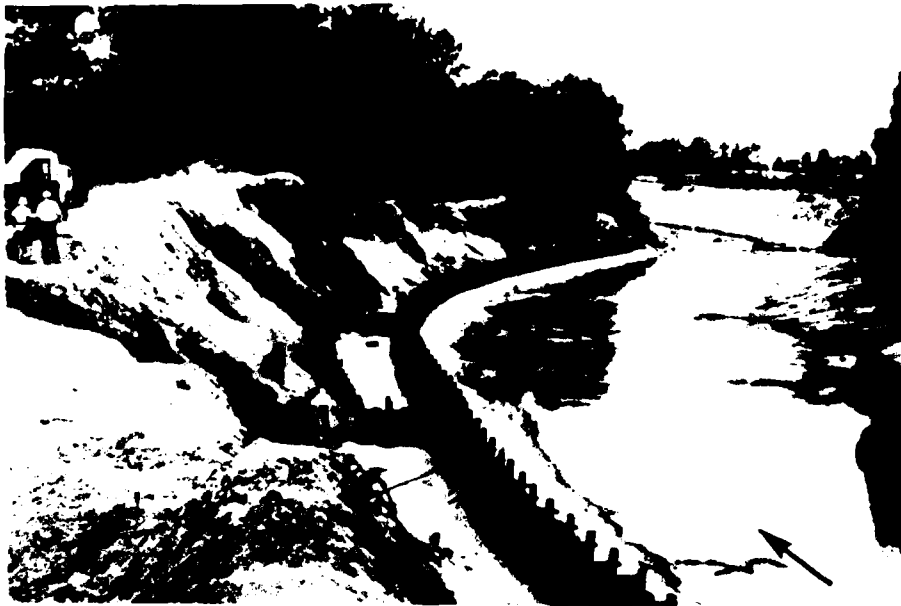
Figure 91. Photographs of used tire wire cribs

Tire Crib Retards
During Construction
Looking Downstream
July 1977

Emntv Tire Crib Retards After
Several High Events
Looking Downstream
Jan 1978

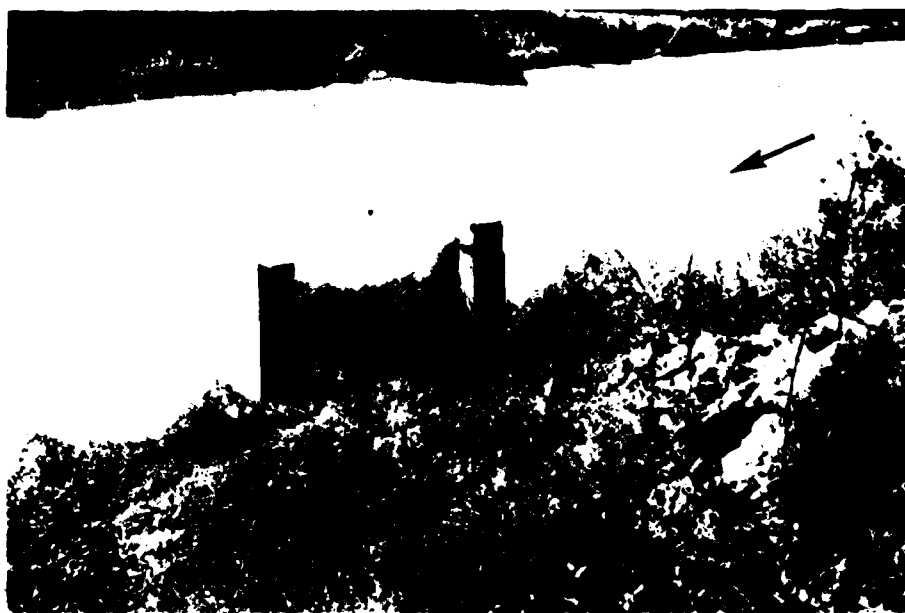
Figure 92. Photographs of cable-fence

Transverse Cable Fence Dike
South Fork Tillatoba Creek
Dec 1976

Transverse Cable Fence Dike
South Fork Tillatoba Creek
Oct 1977

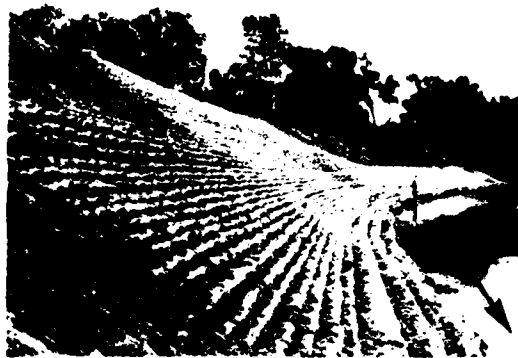
Looking Upstream After
Construction
Sand Cement Bag Revetment
July 1977

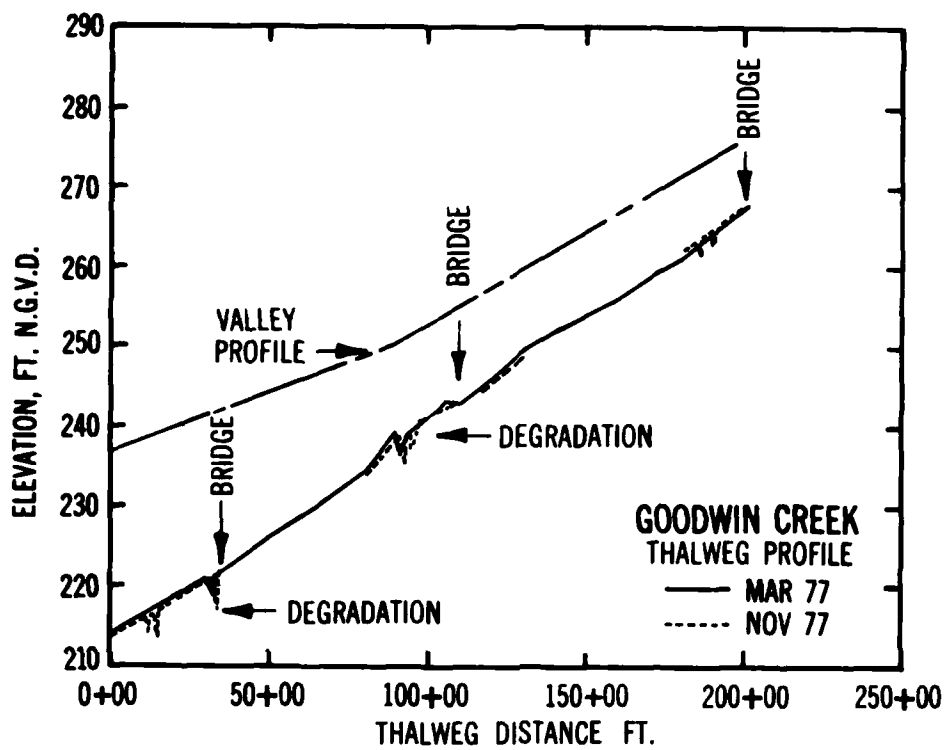
Figure 109. Thalweg profile, Goodwin Creek

Thalweg profiles of March and November, 1977 for Goodwin Creek show degradation continuing along the reach from the mouth to station 49+00 and from 56+00 to 125+00 (Figure 109).

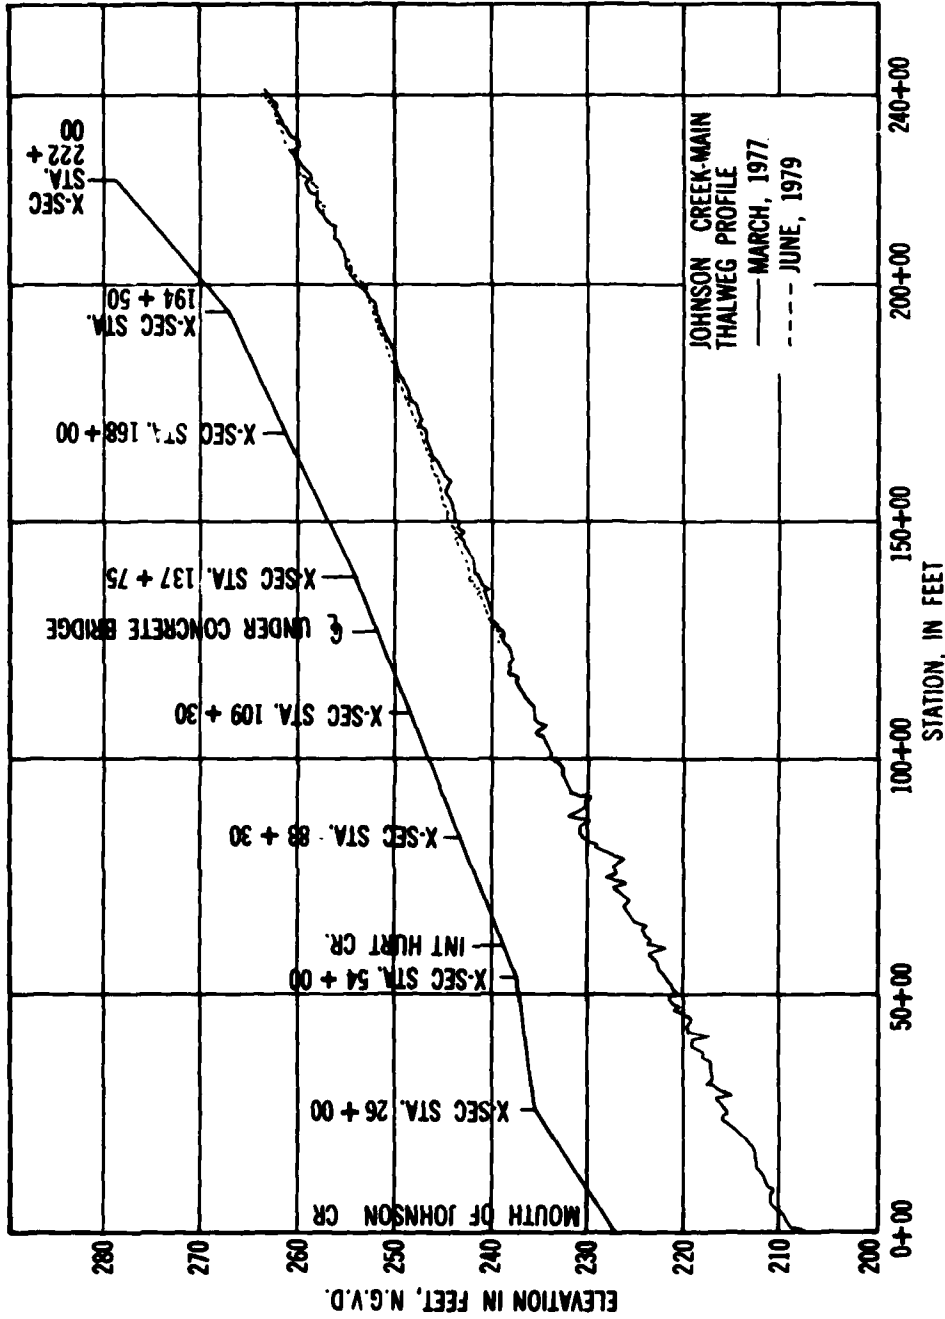
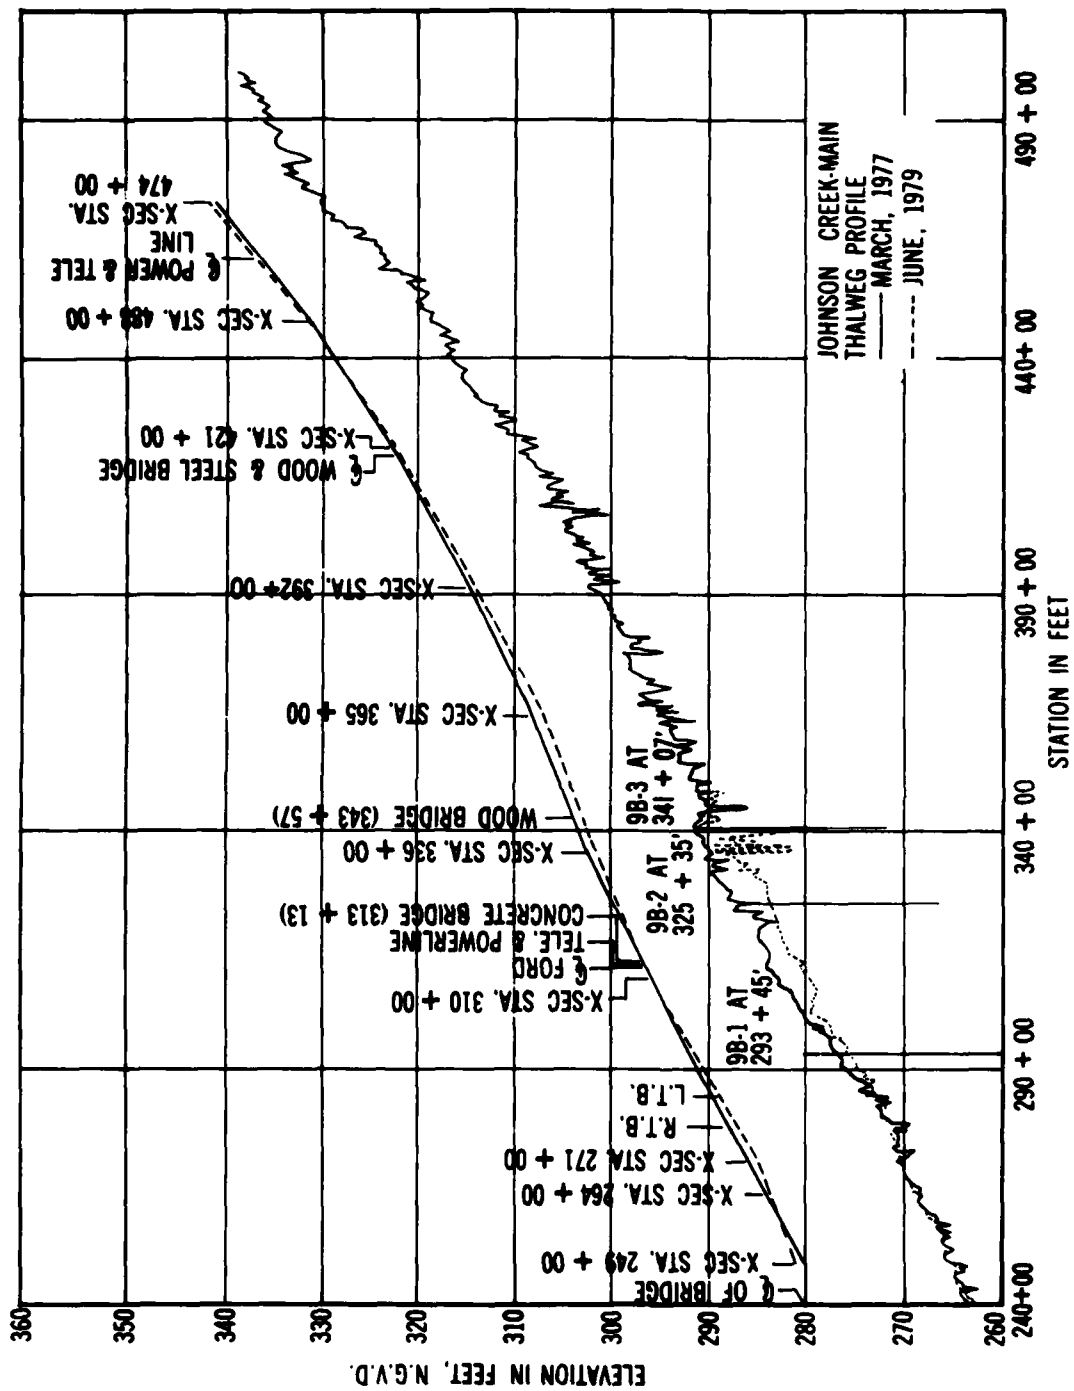
Johnson Creek channel has and is continuing to undergo channel alterations due to advancing headcuts. These headcuts are migrated upstream at an average rate of 550 ft/yr. Channel width alterations show width increases of 300 percent below headcuts. Thalweg profiles of 1977 and 1979 show degradation with a range of two to eight feet from station 290+00 to 340+00 over this 2-year period (Figures 110 and 111). The only

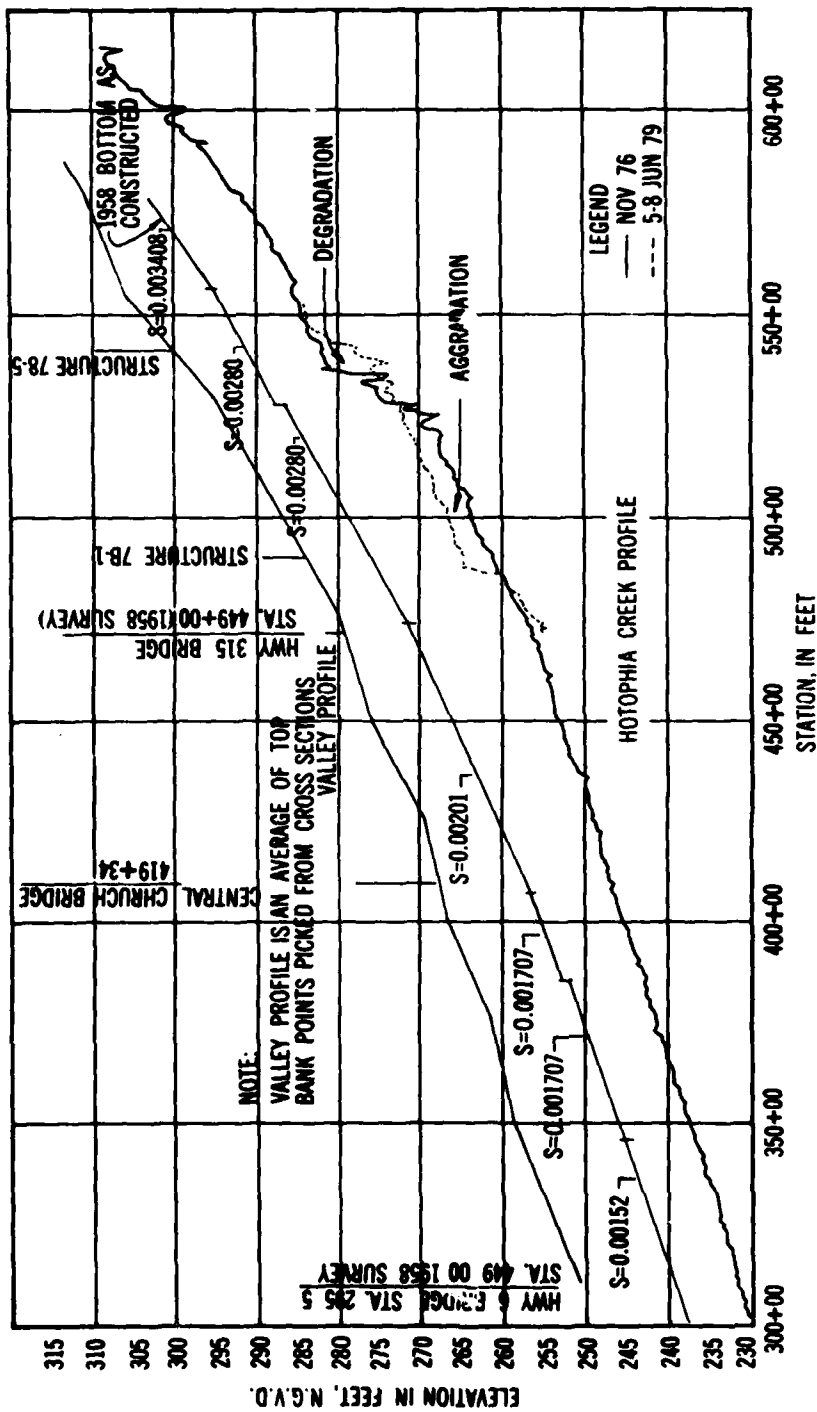
Figure 112. Thalweg profile, Hotophia Creek, 300+00 to 600+00

Channel changes continue along Hotophia Creek as headcuts advance upstream. Thalweg profiles of 1976 and 1979 show the resulting aggradation and degradation as these headcuts advance (Figure 112). Aggradation ranging from 2.5 to 3 feet has occurred from station 489+00 to 525+00 and degradation of up to four feet continues upstream from 525+00 to 555+00.

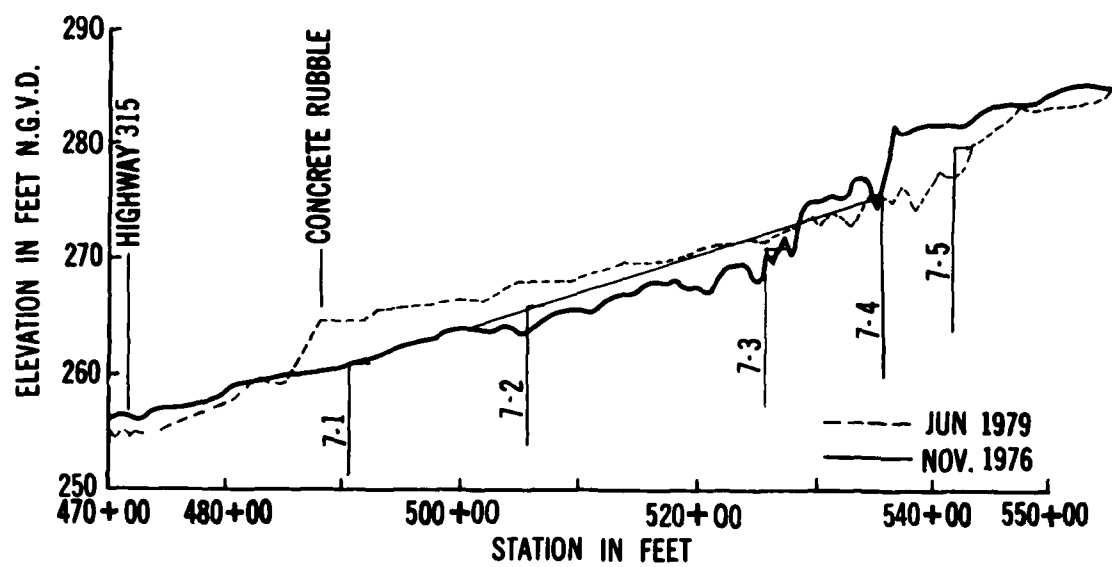
Figure 138. Thalweg profile on Hotophia Creek

A stable grade was selected for the stream from thalweg profile data available and a system of four grade control structures were designated to maintain this grade. A fifth structure was planned upstream to prevent excessive degradation from proceeding to the upstream reaches of the stream. The location and elevations of the structures necessary to produce the desired grade were selected from thalweg profiles. However, when the site surveys were performed, it became apparent that the stream had aggraded several feet in the area of the proposed structures. This aggradation is shown in Figure 138.

This aggradation was the result of a local landowner placing concrete rubble in the streambed below Site 7-1 in an attempt to construct his own grade control structure. Assuming that this temporary dam would be flanked and the impounded sediment flushed out, the grade control structures were built to the original design elevation. This required extensive excavation at the lower three sites in order to place the weir invert at the design elevation. After placement of the structures, bed sediment filled in the excavations leaving the structures either partially or completely buried in the streambed. Recent photos of the structures are shown in Figure 139.
